The Home Buyers Protection Company

19:19 February 01, 2017

Property Information

City: Omaha State: NE Zip: 68116

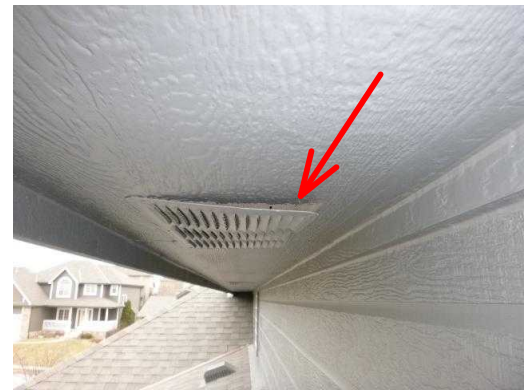
Roof Ventilation: Roof and soffit vents. One soffit vent is loose at the upper roof above the back of the garage. Suggest it be refastened.

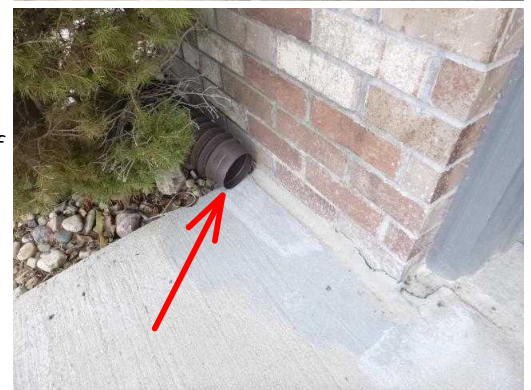
Gutters & Downspouts: Metal. Suggest a downspout extension be installed at the SE corner of the garage to direct water away from the structure. There are water bottles in the gutters on both sides of the small roof over the deck - suggest they be removed.

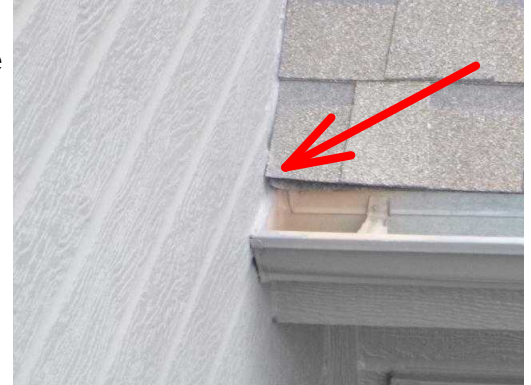
- Flashings: Metal. No kick-out flashings are present where the gutter meets the siding at both sides of the small roof above the deck. Kick-out flashings are needed to prevent water from draining behind the siding. Repairs are recommended.

1. **Flashings: Metal.** No kick-out flashings are present where the gutter meets the siding at both sides of the small roof above the deck. Kick-out flashings are needed to prevent water from draining behind the siding. Repairs are recommended.

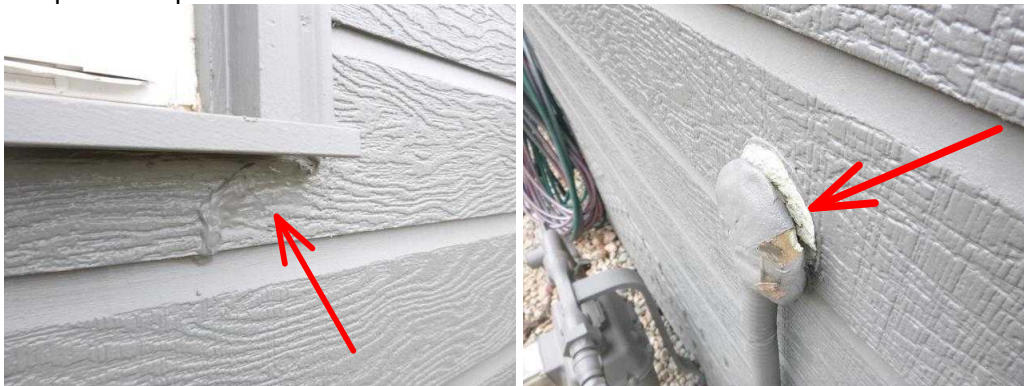
Siding Type: Composition Board. Siding has begun to deteriorate in a small area under the SW main floor window. This was probably caused by a leak at the window trim. Window and siding have been caulked. Maintain the caulking to prevent further deterioration. Siding in contact with the ground at the SW corner. This is not recommended. A couple pieces of siding have been replaced at the east side of the garage and SW corner of the house. Suggest the joint be re-caulked where the gas line passes through the siding at the south side of the house. Composition board siding is susceptible to deterioration from water. It is important to keep it well painted and sealed.

1. **Siding Type:** Composition Board. Siding has begun to deteriorate in a small area under the SW main floor window. This was probably caused by a leak at the window trim. Window and siding have been caulked. Maintain the caulking to prevent further deterioration.
Siding in contact with the ground at the SW corner. This is not recommended.
A couple pieces of siding have been replaced at the east side of the garage and SW corner of the house. Suggest the joint be re-caulked where the gas line passes through the siding at the south side of the house.
Composition board siding is susceptible to deterioration from water. It is important to keep it well painted and sealed.
2. **Exterior Doors:** Handle is loose at the front door. Recommend it be better secured.
Track/trim has some damage at the patio screen door. This does not affect the operation of the screen door.

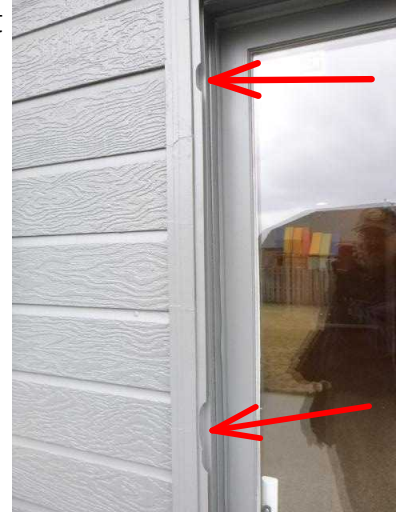
Track/trim has some damage at the patio screen door. This does not affect the operation of the screen door.

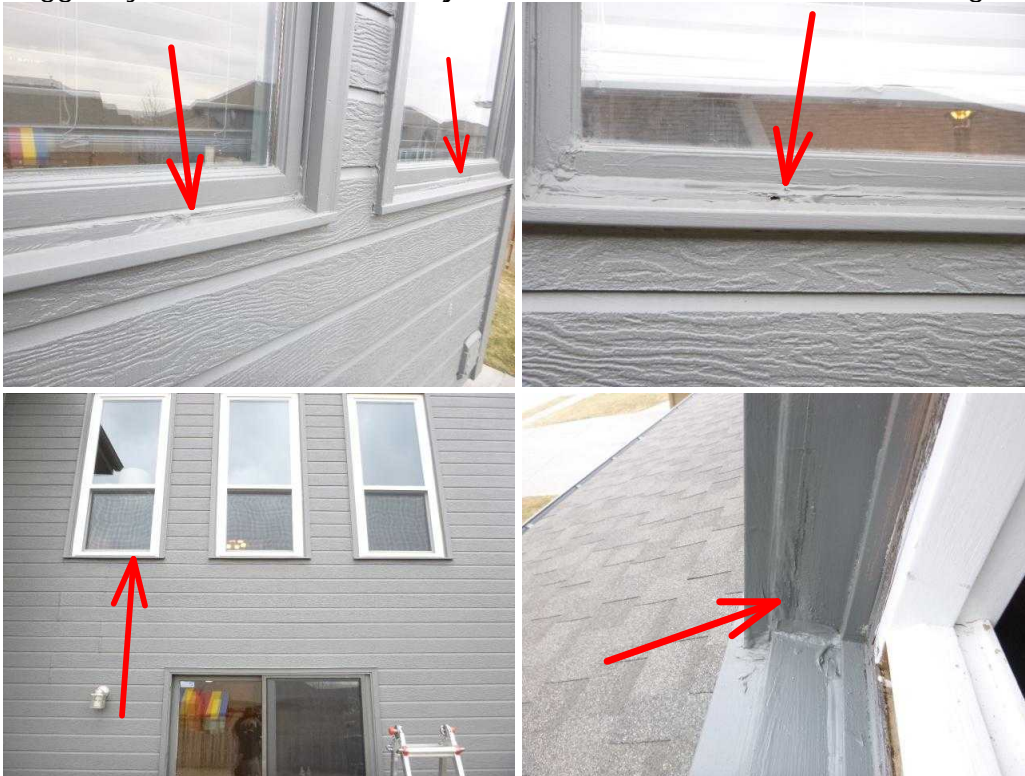
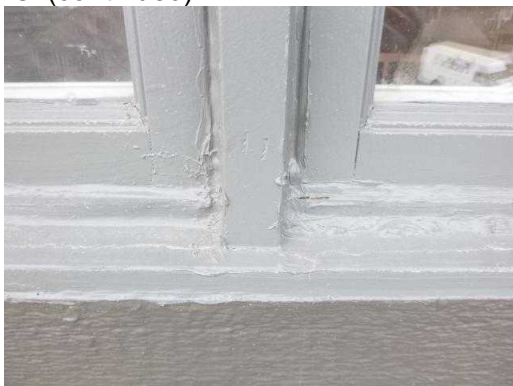
Window Frames/Sills: Wood rot present at the west main floor windows by the deck stairs, at the east window of the three at the main floor family room, at the window on the south side of the house and at the 2nd floor bedroom window on the east side of the house. Repairs are recommended.

Wood is beginning to deteriorate at other east, 2nd floor windows. Recommend they be checked by a qualified contractor.

2. **Window Frames/Sills:** Wood rot present at the west main floor windows by the deck stairs, at the east window of the three at the main floor family room, at the window on the south side of the house and at the 2nd floor bedroom window on the east side of the house. Repairs are recommended. Wood is beginning to deteriorate at other east, 2nd floor windows. Recommend they be checked by a qualified contractor. Suggest you caulk/seal all trim joints around windows where caulking is cracked/missing.

Suggest you caulk/seal all trim joints around windows where caulking is cracked/missing.

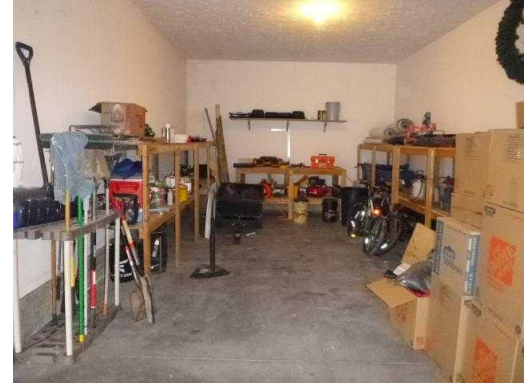
Floor/Foundation: Concrete floor. Foundation wall cracks are present. They do not appear to me to indicate a significant problem at this time. Personal belongings, at the perimeter of the garage walls and floor, limited the inspection.

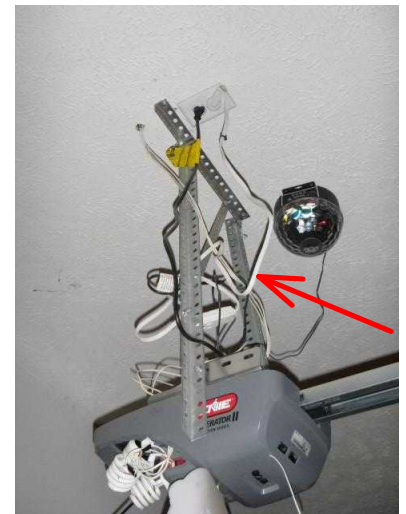
Electrical: 120 VAC outlets and lighting circuits. Extension cord used as permanent wiring at one garage door opener. This is not recommended.

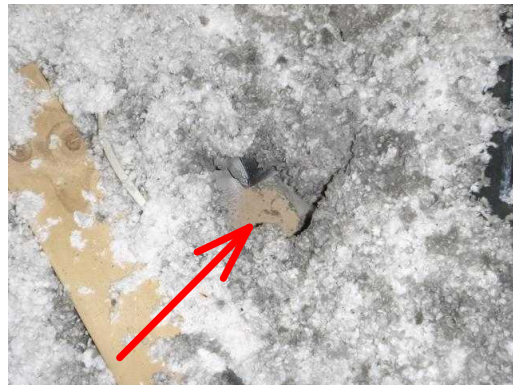
Ventilation: The toilet room exhaust fan vents into the attic insulation. Recommend an extension pipe be installed on it to vent out of the attic.

3. **Master Bathroom Ventilation:** The toilet room exhaust fan vents into the attic insulation. Recommend an extension pipe be installed on it to vent out of the attic.

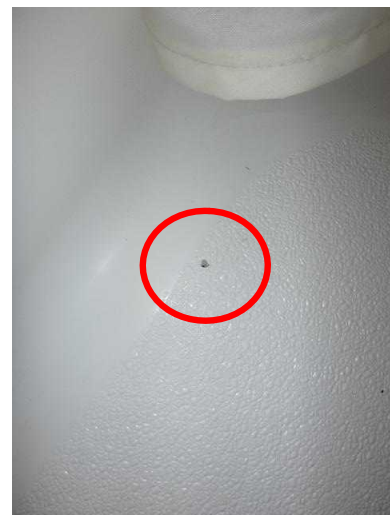
Tub/Surround: There are a few small chips in the tub floor - suggest they be caulked/repared. Faucet handle at the tub turns all the way around. This is unusual but does not appear to be a significant issue at this time. Future repairs may be needed.

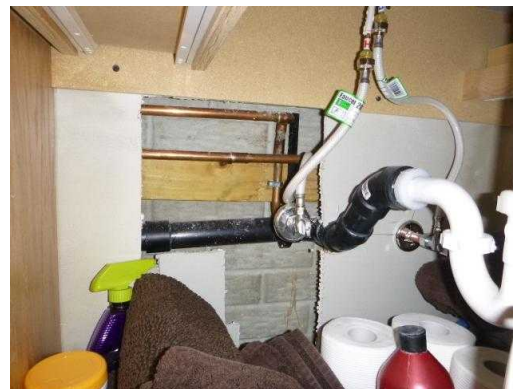
Ceiling/Walls/Floor: The wall is open under the sink.
This was probably done to make a plumbing repair.

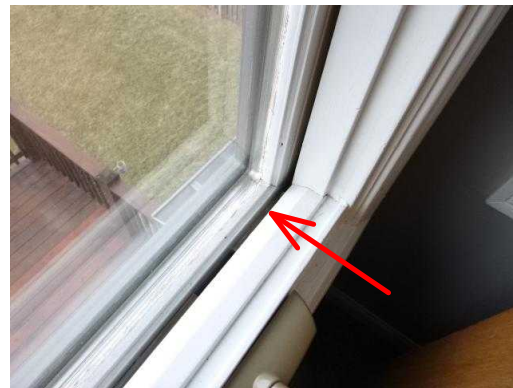
Windows: West window in the NW corner of the master bedroom does not close properly. There is a gap when the window is closed. Recommend further evaluation and repair by a qualified contractor. West window at the basement family room sticks and is difficult to open. Windows are dirty which limited the inspection of the thermal seals.

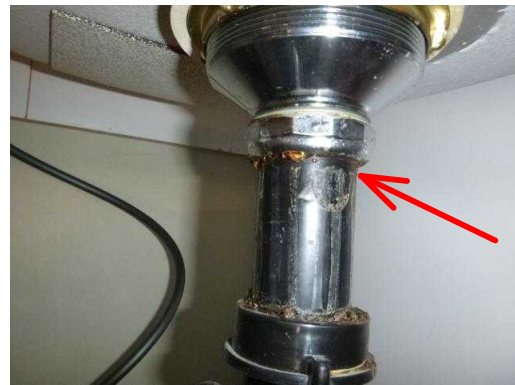
Sink/Faucet: Double bowl with spray hose. It appears the sink drain line has leaked in the past under the right sink bowl. No leaking was observed today. Monitor it. Future repairs may be needed.

10. Main Level Kitchen Sink/Faucet: Double bowl with spray hose. It appears the sink drain line has leaked in the past under the right sink bowl. No leaking was observed today. Monitor it. Future repairs may be needed.

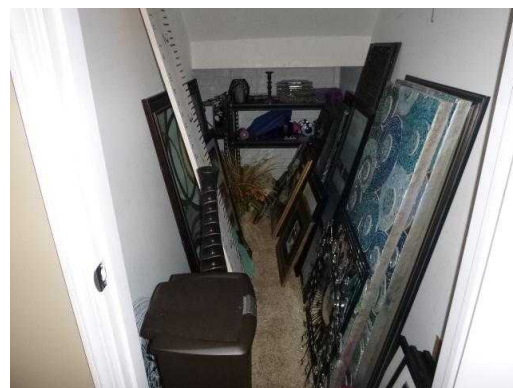
- Structure Type: Masonry and wood frame
- Foundation Walls: Poured Concrete. Narrow cracks in foundation walls - appears to be normal settlement. Monitor them.
Basement/lower level is mostly finished. This limited the visual inspection of the structural components.
Storage/personal belongings in the basement limited the inspection of it and the foundation components.

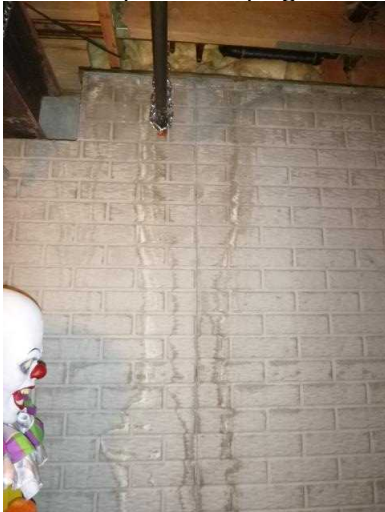
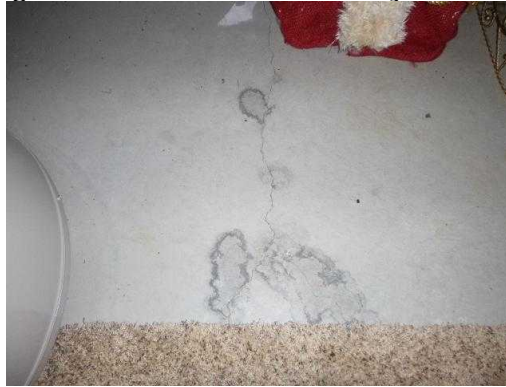
Moisture: Moisture stains present at the south wall in the furnace room, indicating prior dampness/seepage may have occurred. Stains tested dry today. These may be from a past plumbing leak, foundation leak, or may be left over from original construction. Recommend that the buyer request from the seller any information they have concerning any previous or ongoing water seepage that has occurred.

Moisture stains present by the floor cracks in the furnace room. Stains were dry today. These may be from a past leak or condensate at the water heater or furnace, or may indicate prior seepage through the floor. Recommend you ask the seller about this.

12. Moisture: Moisture stains present at the south wall in the furnace room, indicating prior dampness/seepage may have occurred. Stains tested dry today. These may be from a past plumbing leak, foundation leak, or may be left over from original construction. Recommend that the buyer request from the seller any information they have concerning any previous or ongoing water seepage that has occurred.
Moisture stains present by the floor cracks in the furnace room. Stains were dry today. These may be from a past leak or condensate at the water heater or furnace, or may indicate prior seepage through the floor. Recommend you ask the seller about this.

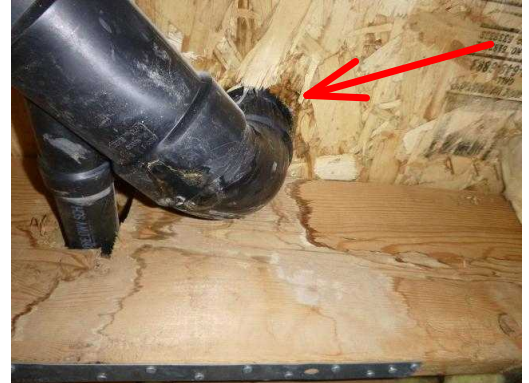
Drain/Waste/Vent Pipes: ABS. There is an active leak at the drain below the main level bathroom toilet. Recommend further evaluation and repairs by a qualified plumbing contractor.

5. **Drain/Waste/Vent Pipes:** ABS. There is an active leak at the drain below the main level bathroom toilet. Recommend further evaluation and repairs by a qualified plumbing contractor.

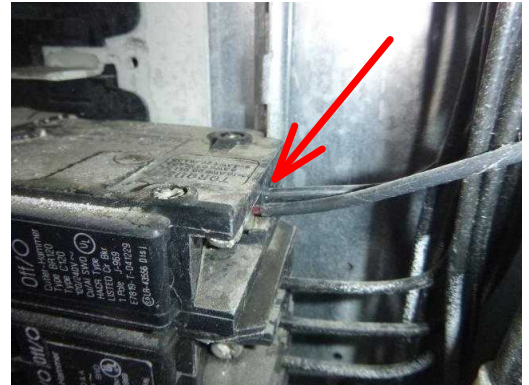
- Breakers/Fuses: Circuit Breakers. One multiple tapped breaker. Recommend repair by a qualified electrical contractor.

4. **Breakers/Fuses:** Circuit Breakers. One multiple tapped breaker. Recommend repair by a qualified electrical contractor.

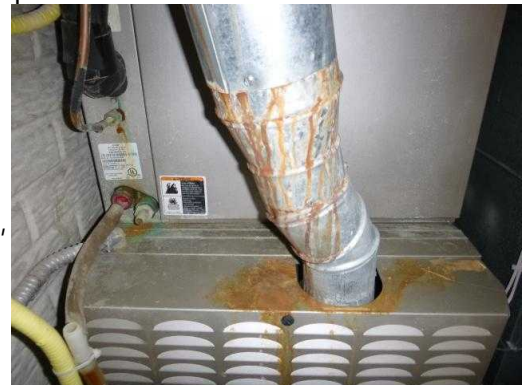
Flue Pipe/Venting: The furnace room is connected to the basement bedroom with a vented door. This is a safety issue. When a door connects a furnace room and bedroom, and the water heater or furnace draw their combustion air from the furnace room, the door must be a sealed, weather-stripped type. In this case, sealing the door between the bedroom and furnace room will create a situation where there is insufficient combustion makeup air available to the furnace room. Recommend further evaluation and repair by a qualified contractor.

It appears that condensate has leaked from the flue pipe in the past. No leaking was observed today.

5. **Basement Heating System Flue Pipe/Venting:** The furnace room is connected to the basement bedroom with a vented door. This is a safety issue. When a door connects a furnace room and bedroom, and the water heater or furnace draw their combustion air from the furnace room, the door must be a sealed, weather-stripped type. In this case, sealing the door between the bedroom and furnace room will create a situation where there is insufficient combustion makeup air available to the furnace room. Recommend further evaluation and repair by a qualified contractor. It appears that condensate has leaked from the flue pipe in the past. No leaking was observed today. Monitor this. Future repairs may be needed.

Monitor this. Future repairs may be needed.

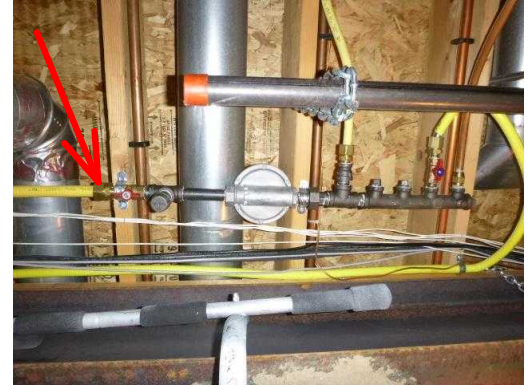
- CSST Gas Lines: CSST (Corrugated Stainless Steel Tubing) gas piping is present. CSST (flexible plastic-coated gas line) should be grounded and bonded. There is a potential for damage to the gas lines from lightning strikes. No ground/bonding wire was located. Recommend further evaluation by a licensed electrical contractor.

6. **CSST Gas Lines:** CSST (Corrugated Stainless Steel Tubing) gas piping is present. CSST (flexible plastic-coated gas line) should be grounded and bonded. There is a potential for damage to the gas lines from lightning strikes. No ground/bonding wire was located. Recommend further evaluation by a licensed electrical contractor.
