The Home Buyers Protection Company

19:19 February 01, 2017

Property Information

City: Omaha State: NE Zip: 68116

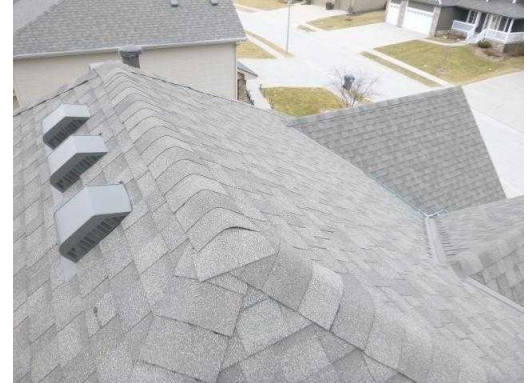
Entire roof Roof Surface

Method of Inspection: Walked on roof

Material: Composition shingle.

Type: Hip and Gable

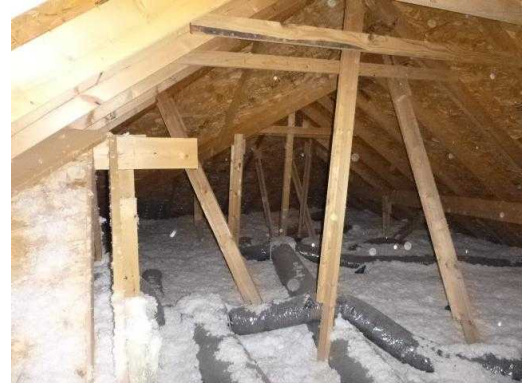
Attic (Continued)

Method of Inspection: Entered the attic.

Unable to Inspect: 30%. Some areas of roof had no accessible attic space below them.

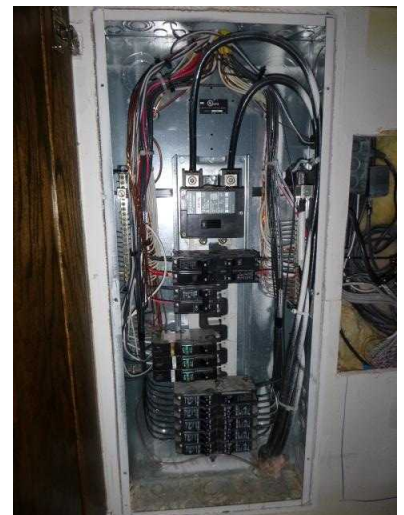
Service Size Amps: 150 AMPS Volts: 120-240 VAC

Service: Underground - Copper.

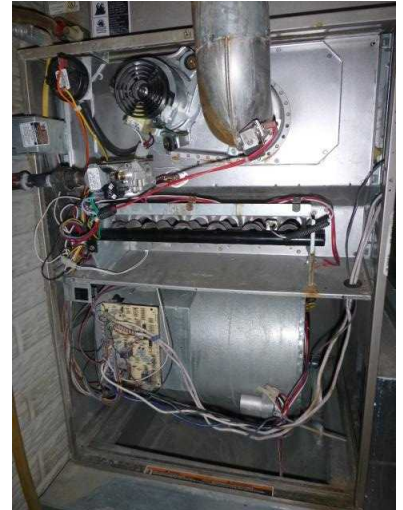
Basement Heating System

General Condition: A carbon monoxide test was performed on the air coming from the furnace and no abnormal levels were observed.

Brand: Carrier.
